The Restoration and Preservation of Pointe Sable Beach

Dr. Anderson Reynolds

Southern Tourism Development Corporation (STDC)

May 9, 2014

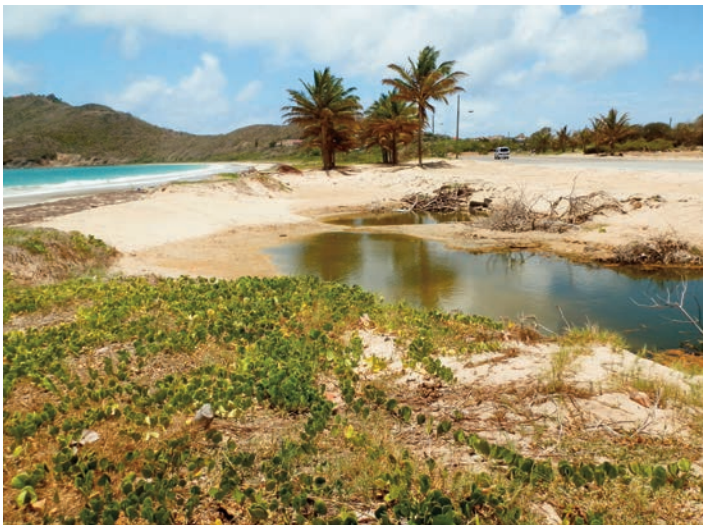
The Trough of 2014 may represent nature’s worse damage to the beach in living memory. The Trough washed away the sand dunes that formed the outer perimeter of the beach. It gorged out the sand in several areas leaving behind several large pits that give the appearance that the beach had been bombed. By denuding the beach of vegetative cover and leaving worn-out tracks, vehicular traffic on the beach created areas of least resistance which intensified the Trough damage. In several areas the gutting of sand followed the vehicular tracks. Inadequate drainage and blocked drains in areas adjacent to the beach, and the leveling of sand dunes across the highway from the beach next to a playing field may have also exacerbated the situation.

As one of the island’s premiere recreation beaches, the damage in the form of unsightly pits and gorges that the Trough left in its wake have robbed the beach of its aesthetics and natural appeal and thus have undermined its recreational value. The Trough

scored the beach of vegetative cover, which served to reduced sand erosion, thus leaving the beach more susceptible to inclement weather. The sand dunes acted as sand, wind, and water breakers, in the process helping to mitigate sand erosion, flooding, and water damage to road and airport infrastructure, thus their disappearance have also left the beach and its surroundings compromised and more vulnerable to future acts of nature.

Considering the recreational, ecological, and economic value of Pointe Sable Beach and the PSEPA, and also the importance of a well maintained beach to flood mitigation and maintenance of road and airport infrastructure, it is imperative that Pointe Sable Beach be restored to its pre-Trough state, and to implement measures to maintain its integrity.

Restoration measures would include beach nourishment (refilling the gorges or pits with appropriate material, rebuilding the sand dunes, creating sand buns or banks along the edges of the beach), unclogging drains, replanting trees and other vegetation, and restricting / controlling vehicular traffic on the beach.
